Energy Efficient Warmer Homes

Terena Plowright
Greening Campaign
TerenaPlowright@gmail.com

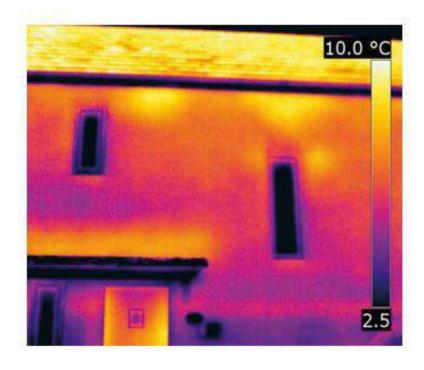
Misleading images

- Reflective surfaces such as glass and metal
- Stored heat (on a sunny day, brick and concrete can store heat and take a long time to cool down)

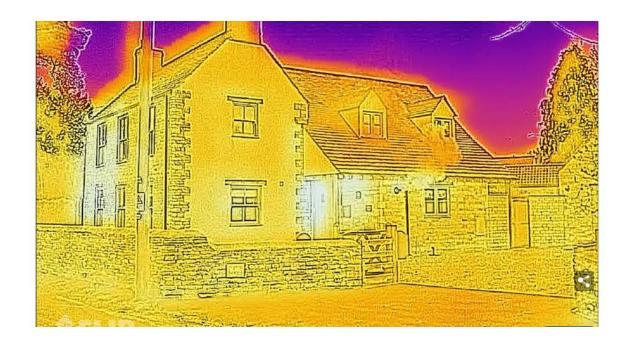
Good insulation as the house walls are a similar colour and temperature to the garden wall and the ground, meaning that the heat is trapped inside the house.

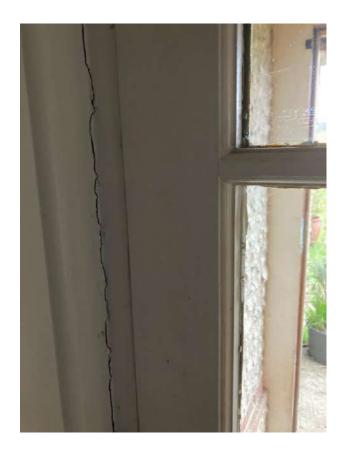
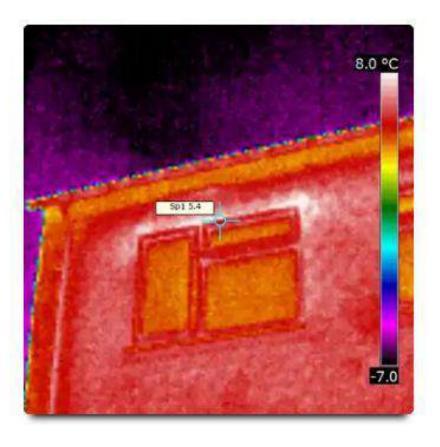
Windows

Heat escaping from above and down the side of the window suggesting a bad seal around the frame.

- Demonstrates the reflective properties of glass as can see the house behind.
- Leaking from top of door/window can sometimes be corrected by adjusting the hinge.

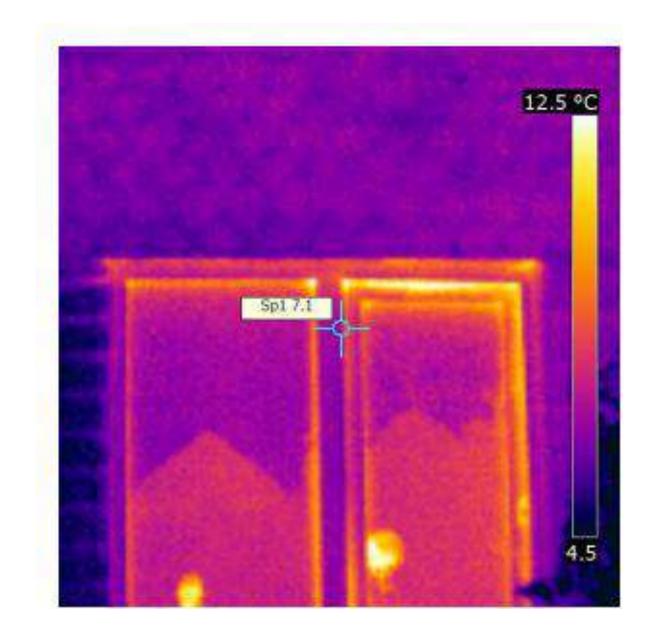
Different effectiveness of double-glazed units in terms of insulation performance. The windows may have lost gas or vacuum over time and now result in higher heat loss. The glazed patio door seems to be a newer unit.

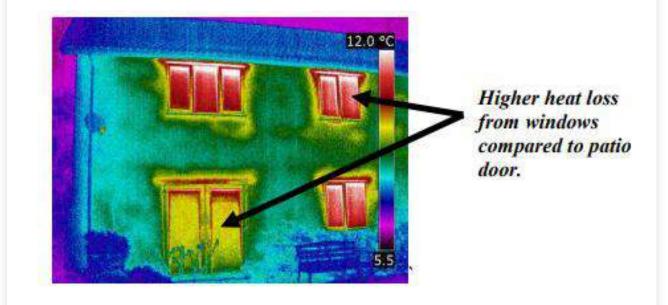
- Also, the same image highlights possible gaps in cavity wall insulation where it may have settled over time.
- And thermal bridging above the windows and patio door where lintels or support beams have not been insulated and are conducting heat from the property.

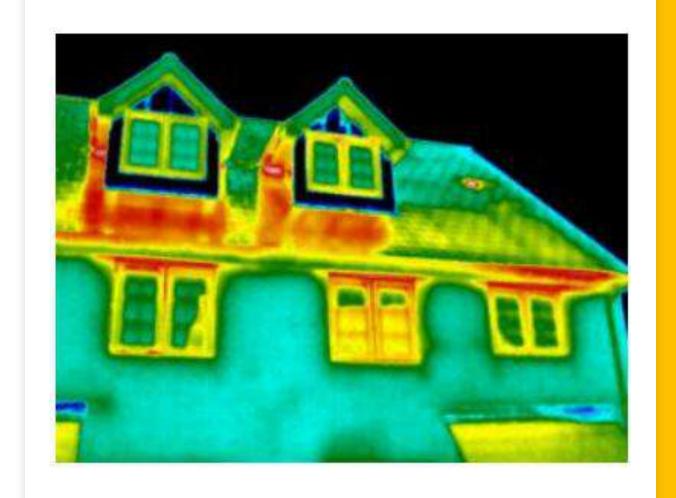
- Insulation has not reached the roof apex
- Insulation not between the ceiling joists creating a bridge

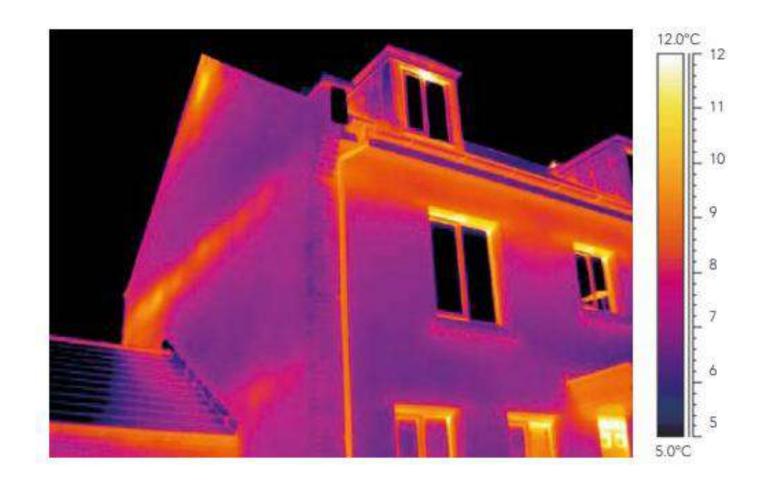
• Heat leaking from where different sections of the building join incorrectly allowing heat to escape

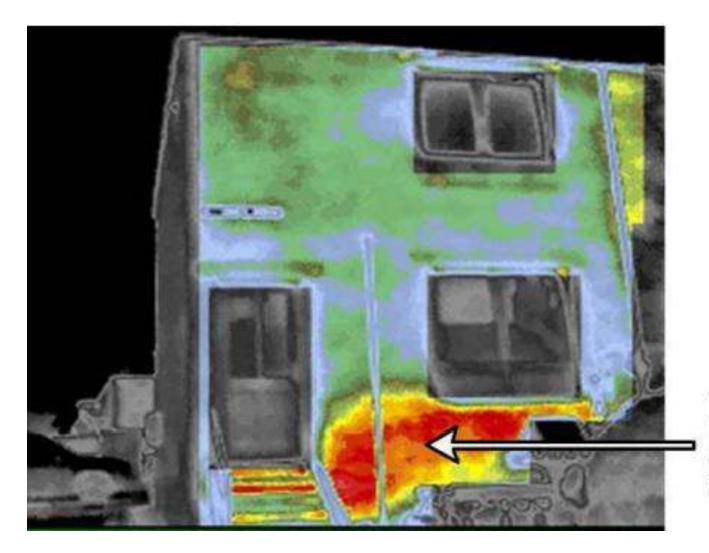
Possible heat loss from radiator

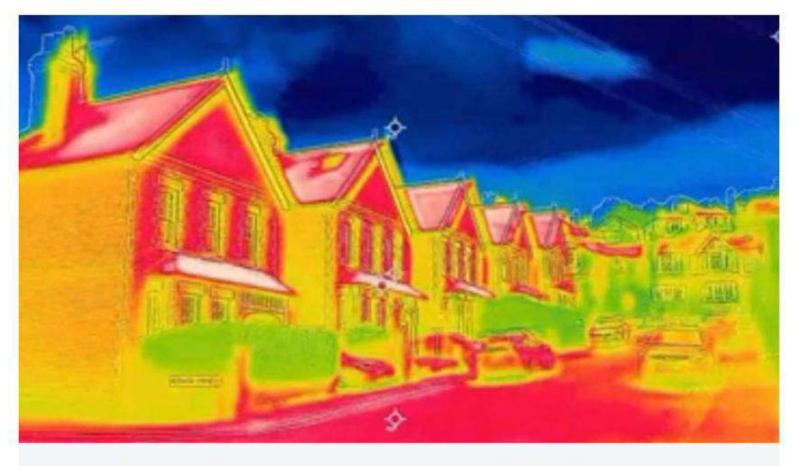
A thermal image showing a street, with houses and the road radiating heat

On a thermal camera it's clear to see the heat radiating from hard surfaces such as brick, steel, concrete and asphalt.
